Subject: Preliminary inspection Reports of two identified black spots in the states of Telangana and Karnataka for reference and guidance (Black Spot ID: KA-055 & TG-058)

Inspection report of state level committee in respect of identified road accident black spot at Dasakodi on NH-48 in the state of Karnataka.

Inspection report of state level committee in respect of identified road accident Black Spot at Uppal Cross Road on NH-163 in the state of Telangana

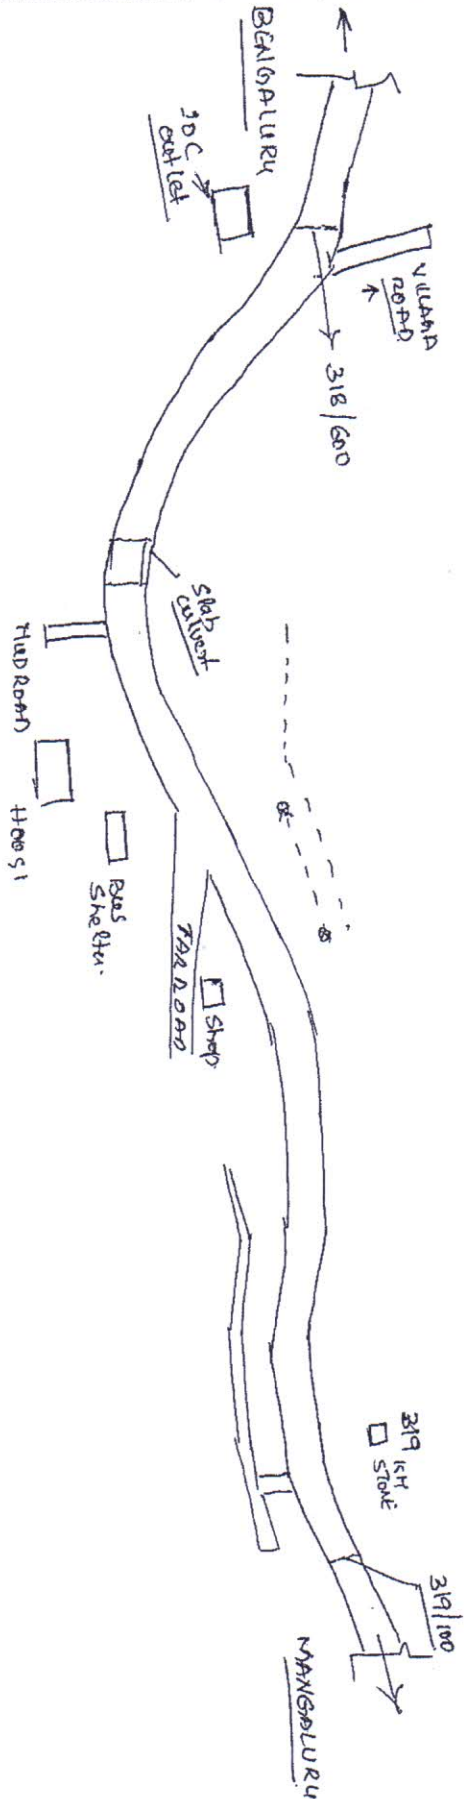
SCHEMATIC SKETCH SHOWING THE DETAILS OF BLACK SPOT AT "DASADIPICH 318/600 TO 319/100"

Inspection methodology and possible reasons for repeated accidents as per site conditions: Discussions with local traffic police and local people were made and it was identified that based on accidents /fatalities taking place in the stretch near Dasakodi, it is appropriate to consider the above black spot stretch from Km 318.600 to Km 319.100 . There is a 'S' curve in the black spot stretch and a village road towards Shamboor and two more village roads are joining the NH without proper junctions. As the stretch is in rolling terrain ruling (i.e., generally adopted) design speed is 80 Kmph and absolute minimum design speed is 65 Kmph. The curve near km 318.73 has very low sight distance of about 45 m (as measured approximately at site) against normal stopping sight distance requirement of 120m and absolute minimum stopping sight distance requirement of 90 m for this NH .The curve at this location has a radius of about 90m.(Chord: 20m,Offset: 0 .78m to inner edge as measured approximately at site i.e., Radius of about 90m) against normal radius of 230m & absolute minimum radius of 155m required for this NH .At next immediate curve near Km 318.600 sight distance as measured is about 45 m and radius is about 110 m (chord 23 m , offset : 0.6m to inner edge of the curve i.e., radius of 110 m) as measured approximately at site against the above normal and minimum requirements of 230m & 155m respectively. There is an Indian oil retail out let on RHS near Km 318.600. There are no edge line markings, no centre line markings, no signs/markings prohibiting over taking etc. There is also severe edge drop between carriage way and earthen shoulders (The sketch of the existing alignment is enclosed at Annexure I alongwith the photographs).

Broad improvements required: Due to high rate of accidents / fatalities taking place at the black spot interim measures are required immediately to reduce accident potential before the 4 laning of this road is implemented. Improvement of curves /sight distance within available land , widening at curves , speed restrictions through rumble strips, road signs/ markings ,improvements and signs at the cross roads ,improvement of camber /super elevation, acceleration/ deceleration lanes at the retail outlet etc. are to be implemented.

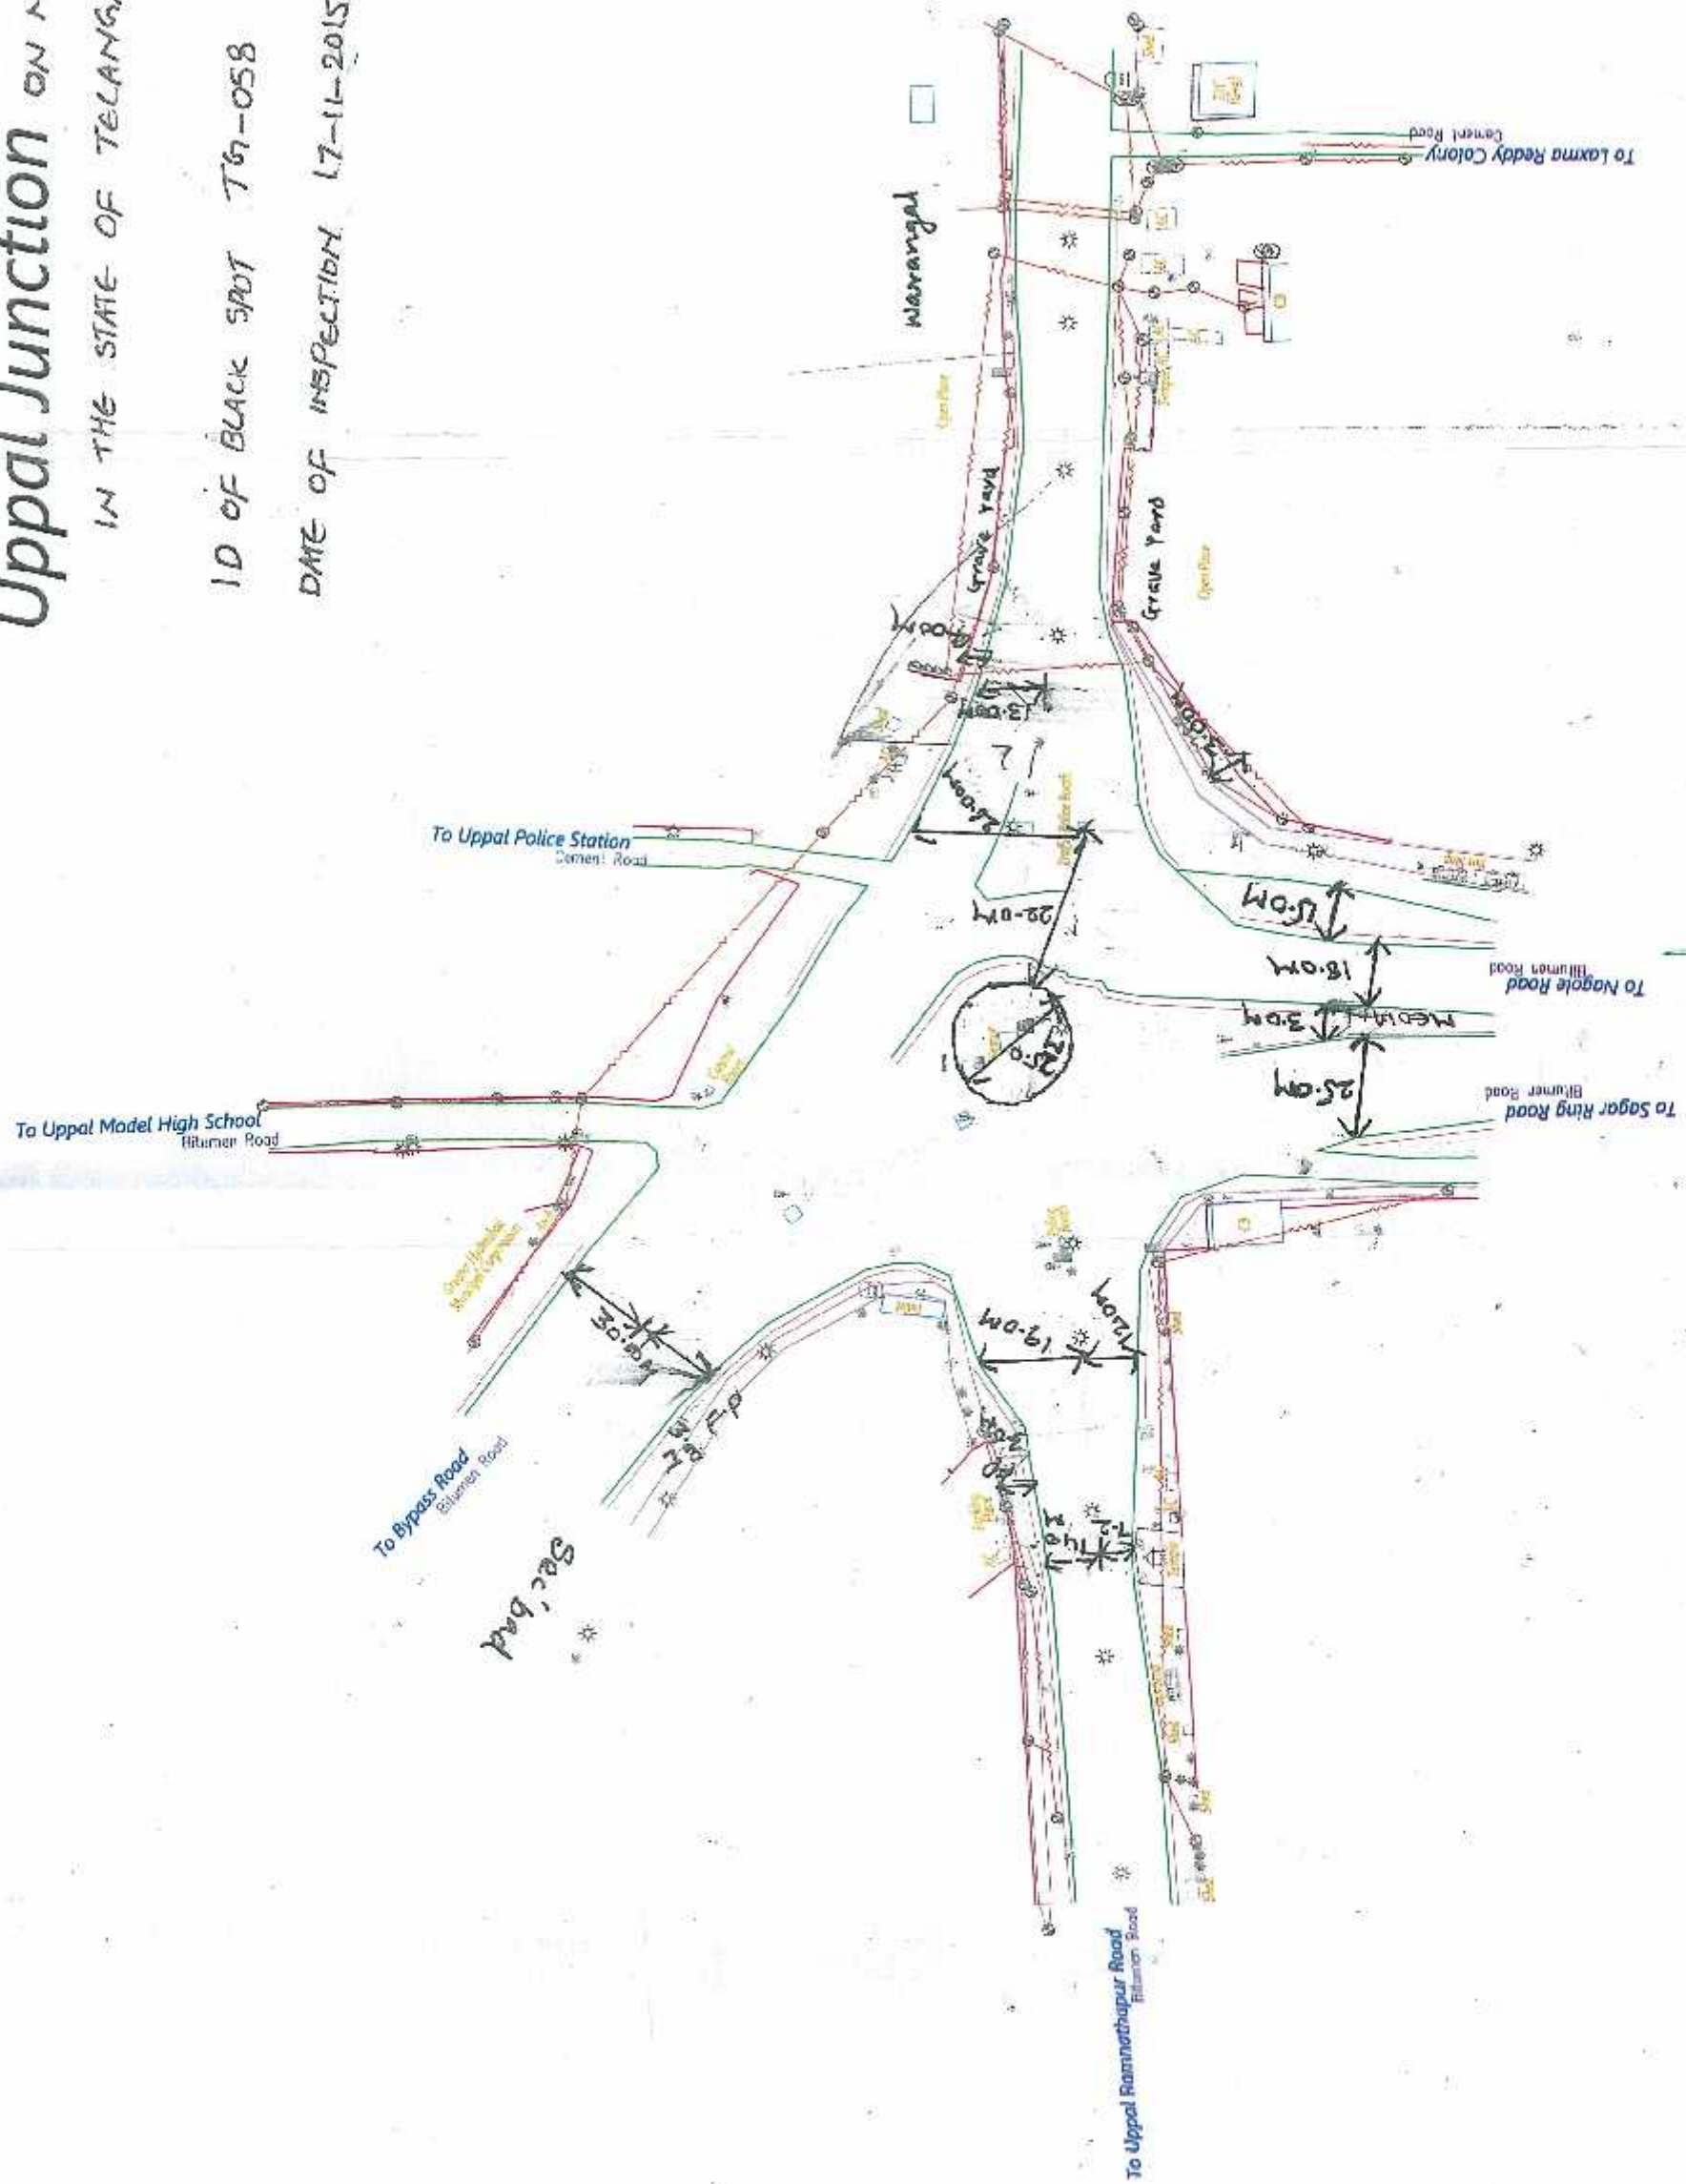
Uppal Junction ON NH-163 IN THE STATE OF TELANGANA

Details of existing road / road environment: This black spot stretch from km 7.5 to km.8.0 is falling on the Uppal Cross Road junction which is a cross junction between 4-lane NH 163 and 8-lane inner ring road which is under Greater Hyderabad Municipal Corporation (GHMC). There is a small rotary in the centre of the junction which has a very small dia of 25m. Presently this rotary is not being used and the traffic is moving through U-turns on the inner ring road. There is Ambedkar Statue on the rotary. NH-163 coming from Chadarghat junction point on NH-65 is slightly deflected towards right. The inner ring road is deflecting substantially towards right. There are no right turning lanes, channelizers, proper pavement markings / road signs. There are a lot of undesirable open spaces within the junction area leading to hazardous weaving maneuvers resulting in unsafe conditions. There is severe unauthorized and irregular parking of vehicles, autos etc. on Warangal leg as well as Nagole leg. Some urban streets are irregularly joining at the junction without any service roads or other facilities. Footpaths are partially existing. No drains are existing. There is no

continuous movement path for the pedestrians. Though signals are existing they are neither functional nor are catering to all the movements at the junctions. There is Uppal Metro station near the junction on Nagole leg. All the unsafe conditions prevailing at this junction need to be remedied through comprehensive proposal based on survey investigations / detailed designs.

Inspection methodology and possible reasons for repeated accidents as per site conditions: Simple measurements of different features of the intersection are taken. Traffic patterns were observed and a rough sketch depicting the site conditions is prepared. Local enquiries and discussions with traffic police were made. Basically the traffic paths have unregulated deflections. The junctions have undesirable open spaces and pedestrians have no facilities. In spite of this being a busy intersection, all traffic movements are not being regulated through signals. There are several pedestrian to vehicle and vehicle to vehicle accidents taking place at this junction as reported traffic police and the local people.

Broad improvements required: Appropriate right turning, acceleration or deceleration lanes are to be created. Proper channelizing islands are to be provided streamlining all the traffic movements maintaining minimum widths for median islands as well as channelizing islands. Several obstructions lying in the intersection area are to be removed. Footpaths/ drains are to be provided. Complete signalization is to be designed / provided catering to all traffic and pedestrian movements. All road signs and pavement markings are to be provided. No parking zones and regulated parking areas are to be established. Bus bays have to be properly relocated and redesigned. Camber and super elevation are to be corrected. A comprehensive proposal is to be designed after preparing a detailed base map super imposing the proposed improvements.
